MAR 8 1973

NBSIR 73-111

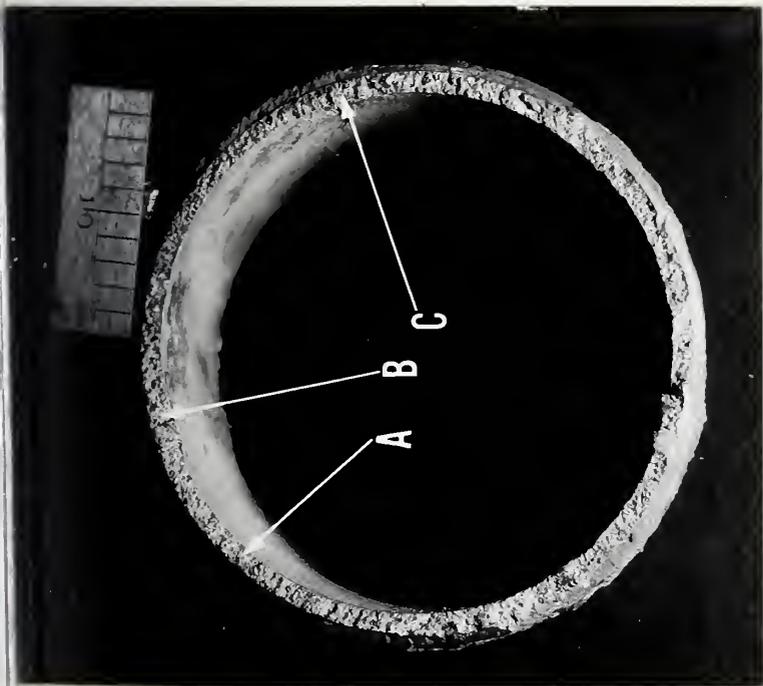
f Specimen failed near grips after extensive corrosive attack.

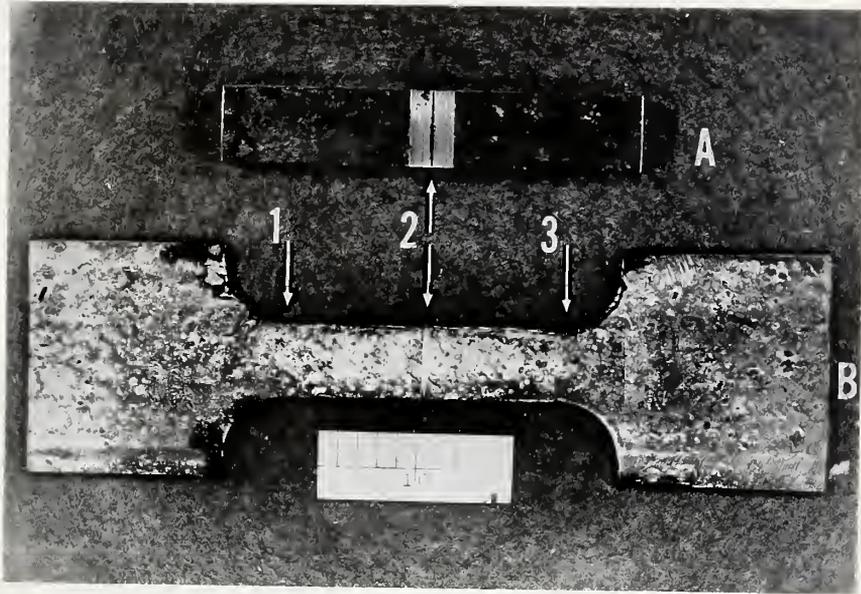
Figure 3. Photographs of Typical Subsize Impact (A) and Short Tensile (B) Specimens. Both specimens are notched at location 2. Measurements of reductions of area and elongation were made on the tensile specimens at locations 1, 2, and 3. About 1X.

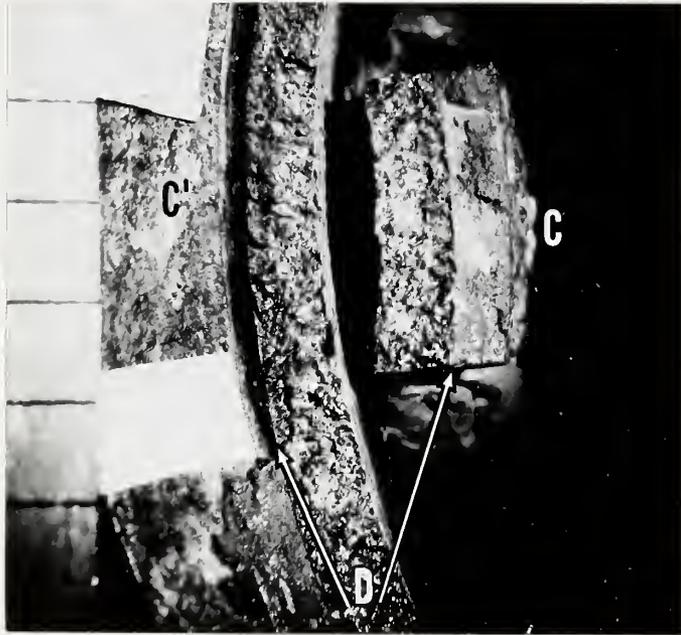
Figure 4. Matching Corroded Fracture Surfaces at Locations C and C'. Root of thread is indicated by the arrows D. The corroded region extends about 1/3 down the fracture surface from the root of the thread. About 5X.

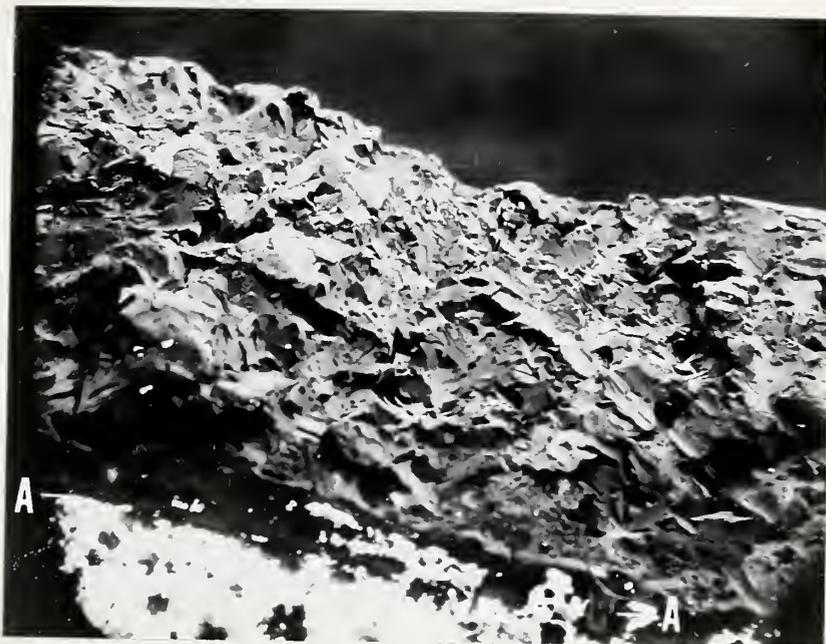
(b) Inclusion content. Unetched.

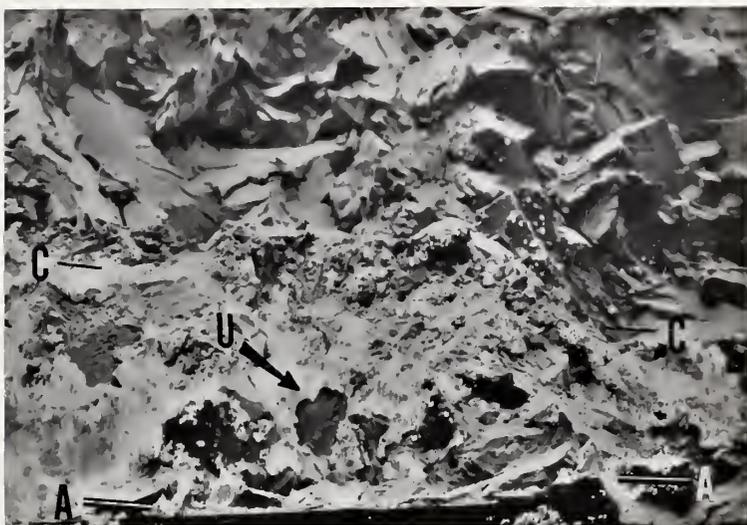
- (a) Junction of corroded and "fresh" regions of fracture surface after ultrasonic cleaning. The face of the pipe thread is located below line A-A, a corroded region of fracture surface between lines A-A and C-C, and "fresh" fracture above line C-C. Arrow U shows where the ultrasonic cleaning removed some corrosion product. 60X
- (b) Junction of corroded and "fresh" regions of fracture surface before ultrasonic cleaning. "White" deposit below line C-C is a corrosion product that does not conduct electricity readily and consequently is charged by the electron beam of the SEM. 33X
- (c) Field near the center of the "fresh" fracture region at higher magnification, showing predominantly transgranular quasi-cleavage, with some evidence of dimpled rupture (between arrows). 130X

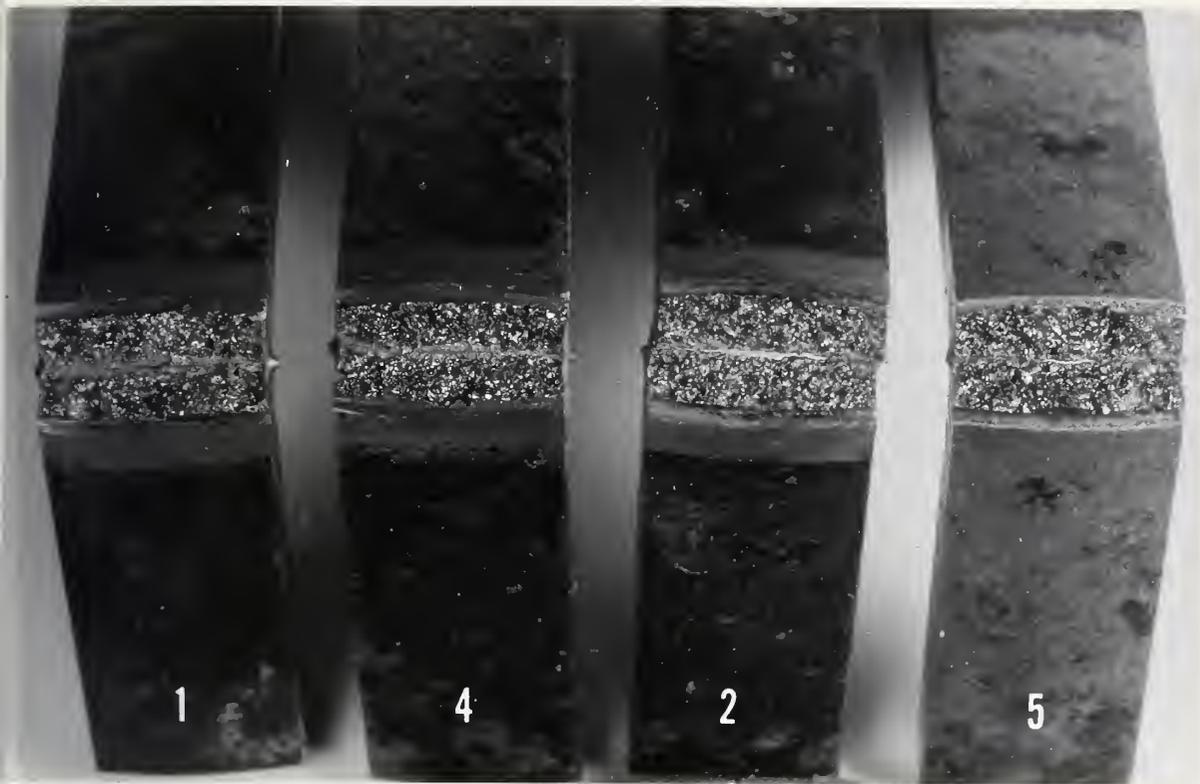
- (a) Specimens 1, 4, 2, and 5 were tested at or below room temperature and show faceted fracture surfaces.
- (b) Specimens 3 and 6 were tested at or above 190° F and did not fracture.

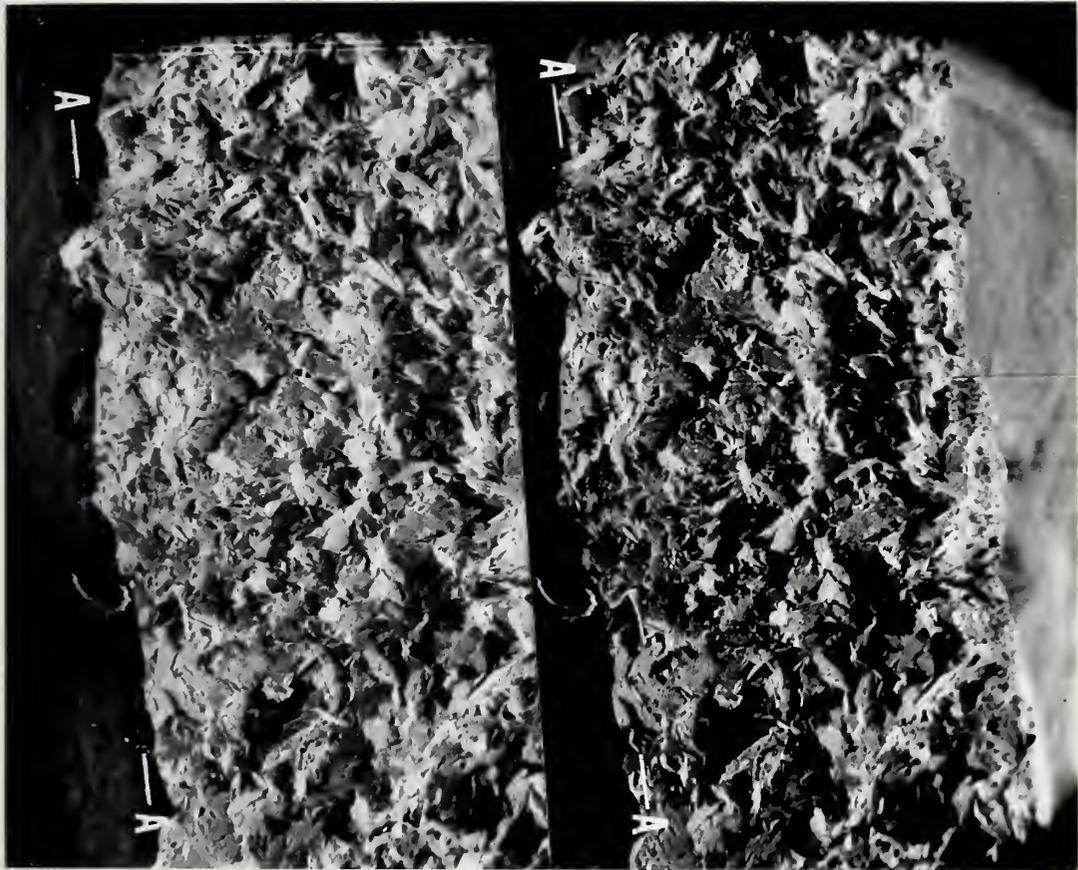
Figure 9. SEM Stereo-Pair Fractograph of Impact Specimen No. 5. Charged with hydrogen, tested at 35° F. Fracture appearance is representative of specimens 1, 2, and 4. Line A-A is the root of the notch. 21X

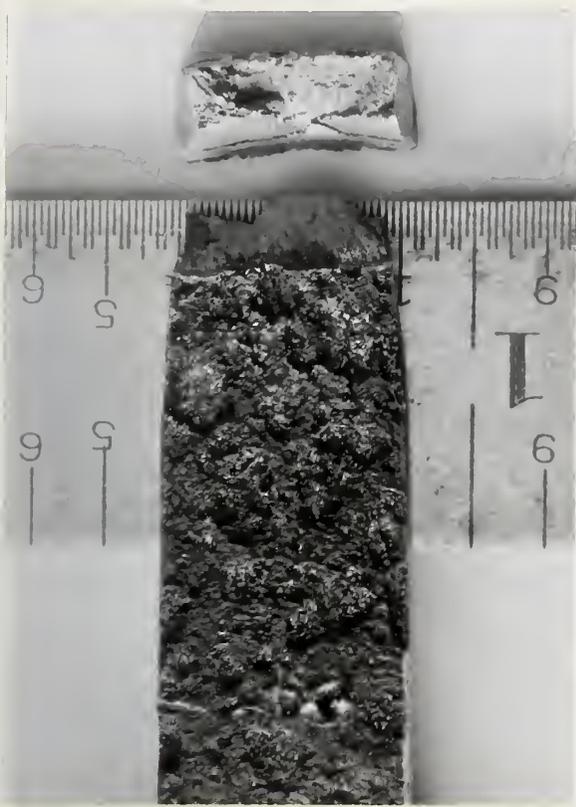
- (a) Specimen No. 3. Uncharged. Tested at 75° F in air.
- (b) Specimen No. 2. Uncharged. Tested at 35° F in water.
- (c) Specimen No. 4. Charged. Tested at 75° F in 5% H₂SO₄ aqueous solution.
- (d) Specimen No. 1. Charged. Tested at 35° F in aqueous 5% H₂HO₄.

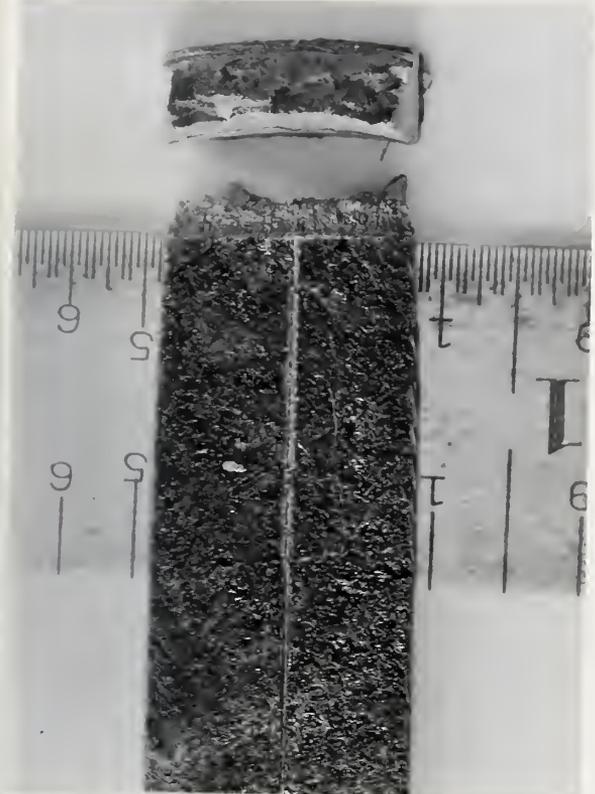
- (a) Specimen No. 8. Uncharged.
Tested at 75° F in air.
- (b) Specimen No. 5. Uncharged.
Tested at 35° F in water.
- (c) Specimen No. 14. Charged.
Tested at 75° F in 1M, Na₂SO₄.
- (d) Specimen No. 6. Charged.
Tested at 35° F in aqueous
5% H₂SO₄.

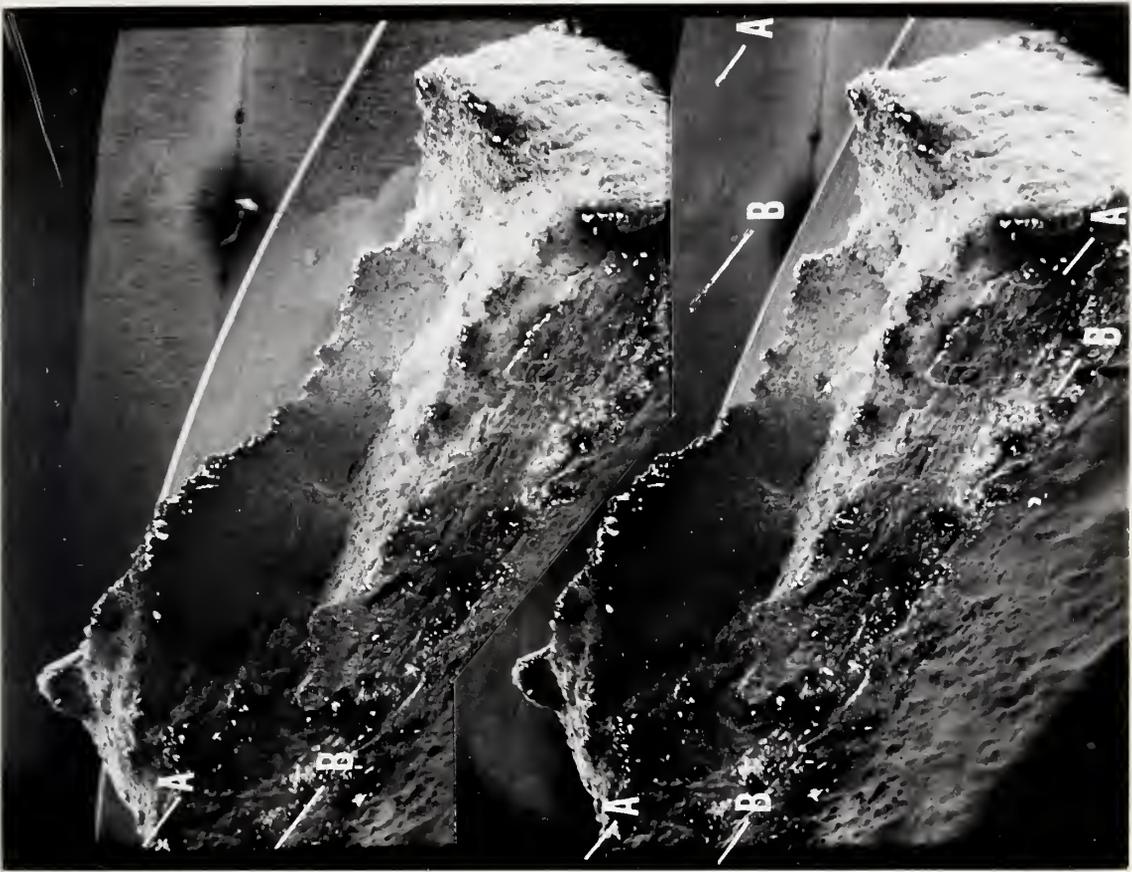
- (a) Stereo pair showing the ductile fracture mode at low magnification. The region between the lines A-A and B-B is the notch deformed during testing. 13X
- (b) The ductile fracture mode (dimpled rupture) shown at higher magnification in region near center of fracture surface. 650X

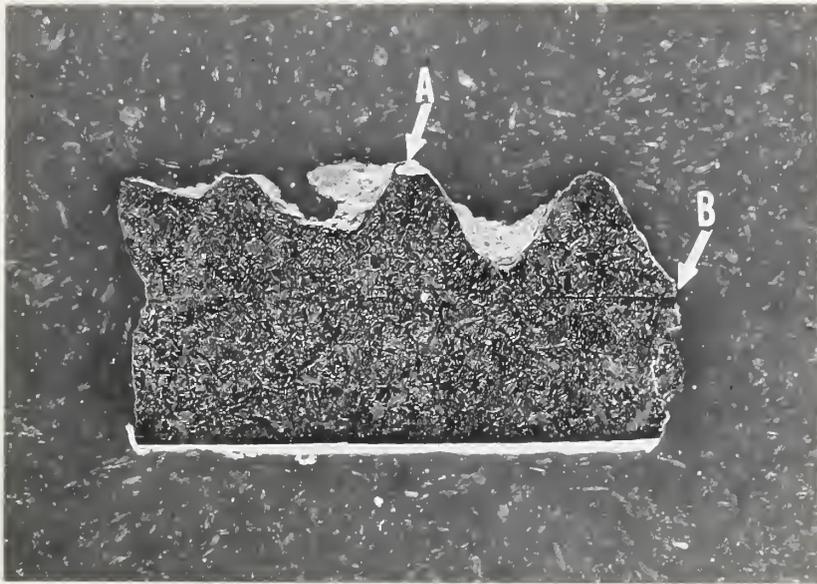
- (a) Location of galvanized coating on tip of second thread from fracture face is shown by arrow A. The fracture face is shown by arrow B. 5% Nital etch. 10X
- (b) Crest of second thread from fracture face (shown in a). Etched very lightly with picral etch. 160X
- (c) Crest of second thread from fracture face at higher magnification. Two layers of iron-zinc intermetallic coating the outer surface of the section can be detected and are shown by arrows C. Etched very lightly with picral. 400X
